Future Solar Developments Inc.

Water Assessment Site Investigation Report
Proposed Ground-Mount Solar LP5 & LP6
8338 Scotchmere Drive
Strathroy, ON

Project Number
WSL-00002250-00

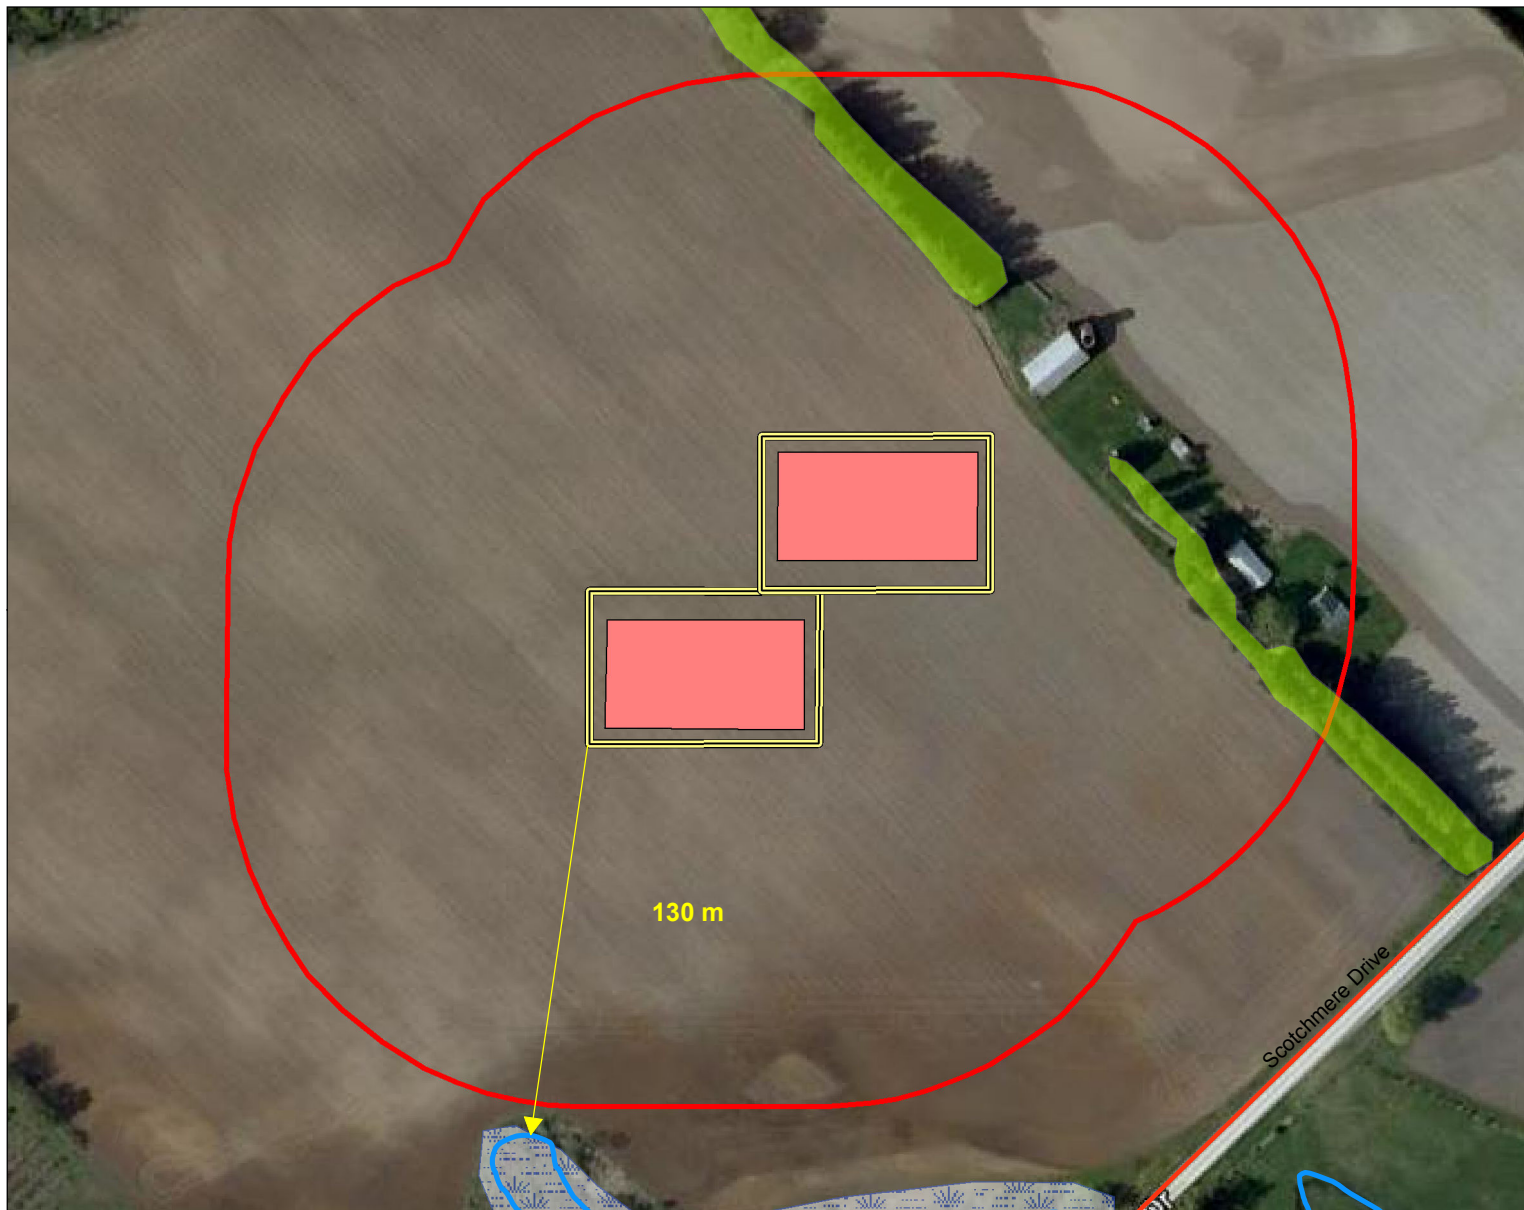
WATER ASSESSMENT
SITE MAP

This section identifies the results of the site investigation and discusses the water features observed and noted in the records review as presented in **Table 1-1**. Features documented in relation to the proposed project location are illustrated on **Figure 1**.

No seepage areas were identified in the records review, and were therefore identified as unknown. During the site investigation, this water feature was assessed in order to confirm the presence or absence of these areas. The site investigation confirmed the absence of seepage areas within the subject property. Komoka/South Strathroy Creek Provincially Significant Wetland is located approximately 130 metres away from the Site.

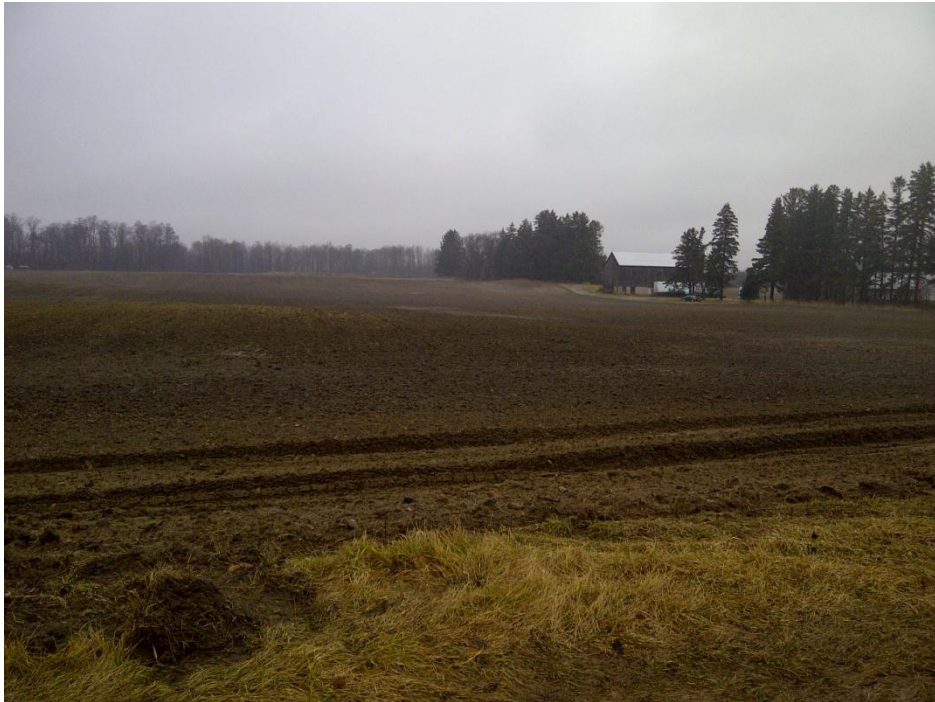
Photograph No.1: Southern edge of property facing north east; proposed site consists of agricultural land

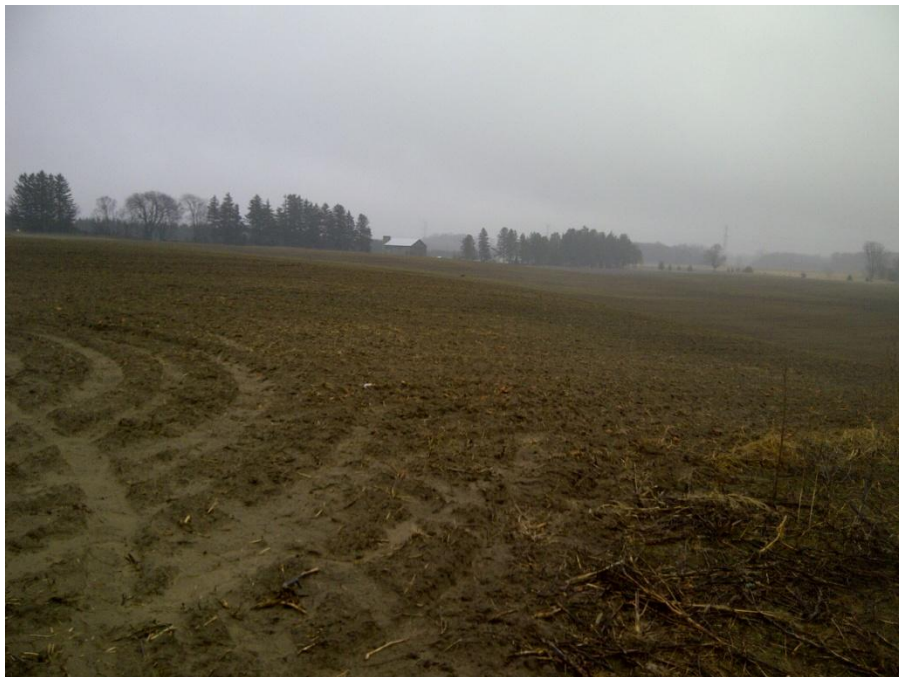
Photograph No. 2: North western corner of property facing south east; slightly depressing topography present in the central portion of the property

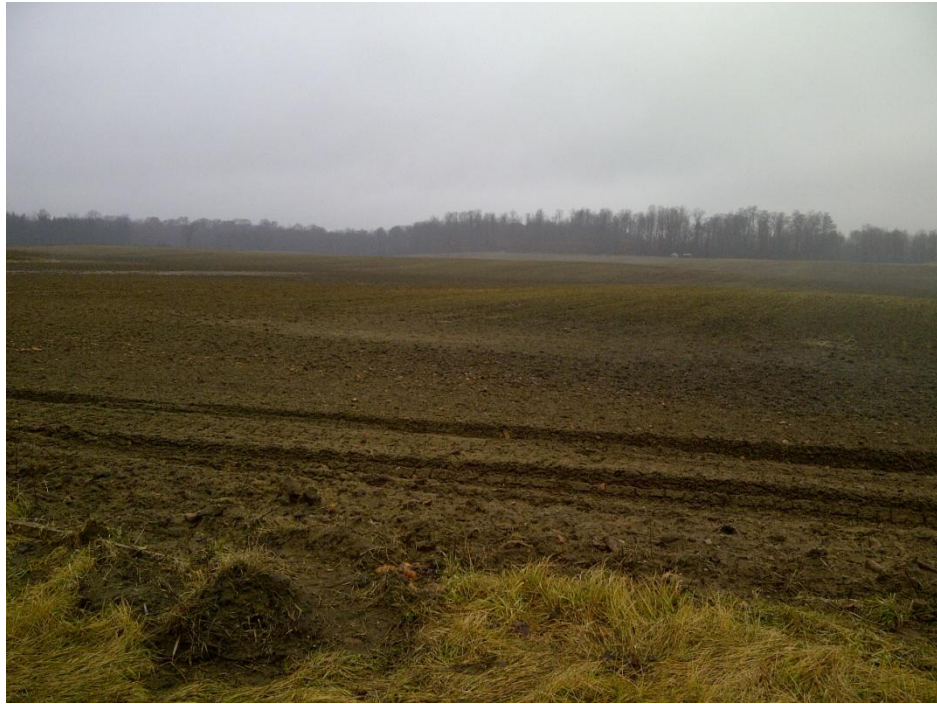
Photograph No. 3: Western edge of property overlooking proposed site facing east; slight depressions in topography present

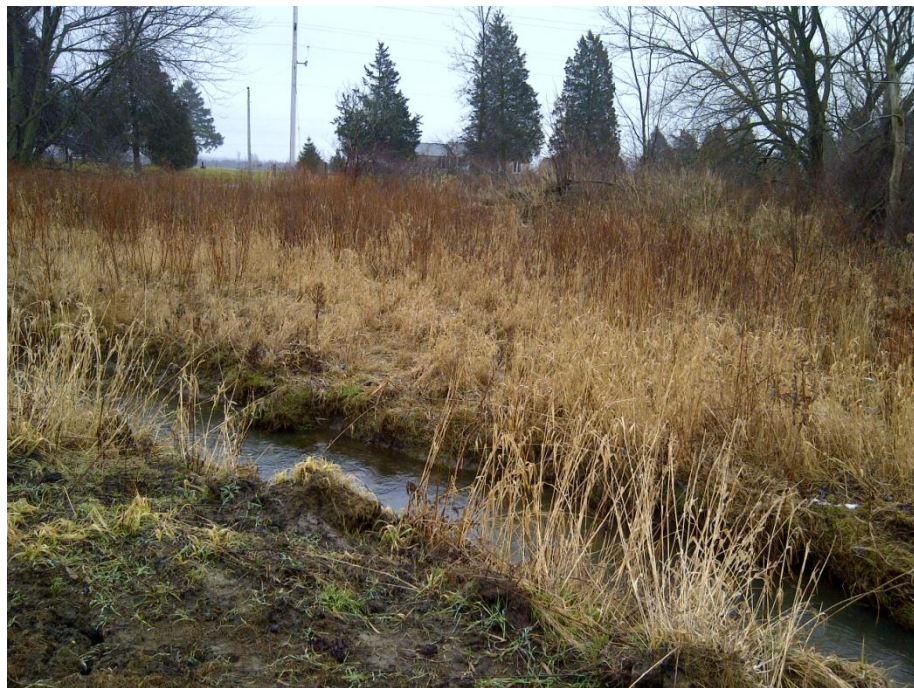
Photograph No. 4: Provincially significant wetland located in the south corner of property. Predominately grasses and sedges present, with a few deciduous species. South Strathroy creek flows along the edge of the wetland.

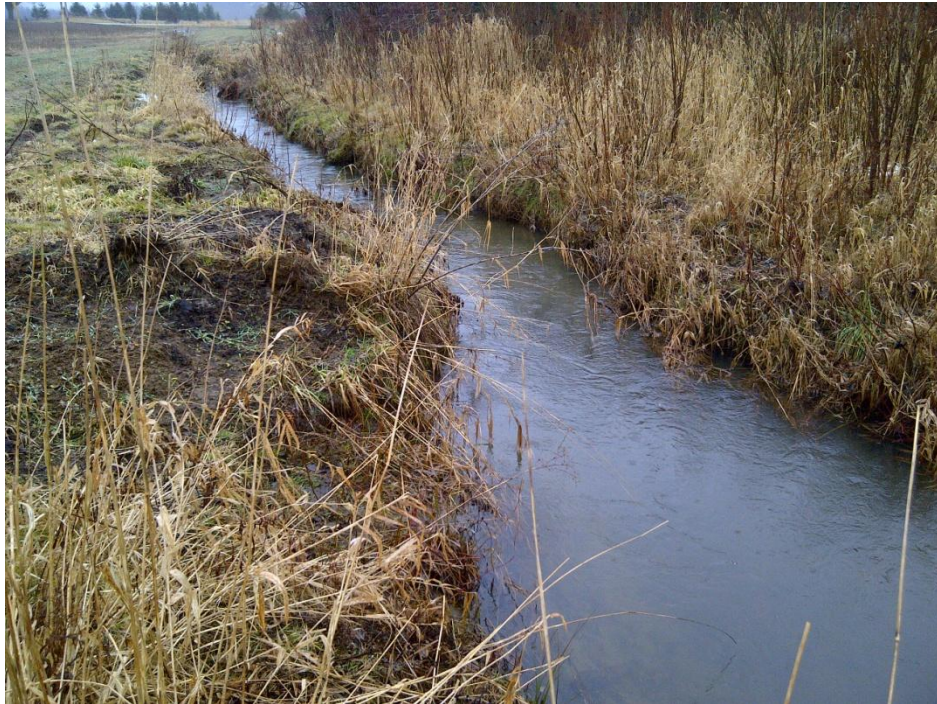
Photograph No. 5: Creek flowing beside the provincially significant wetland in the south corner of the property; creek is approximately one meter wide, and 1-2 feet deep.

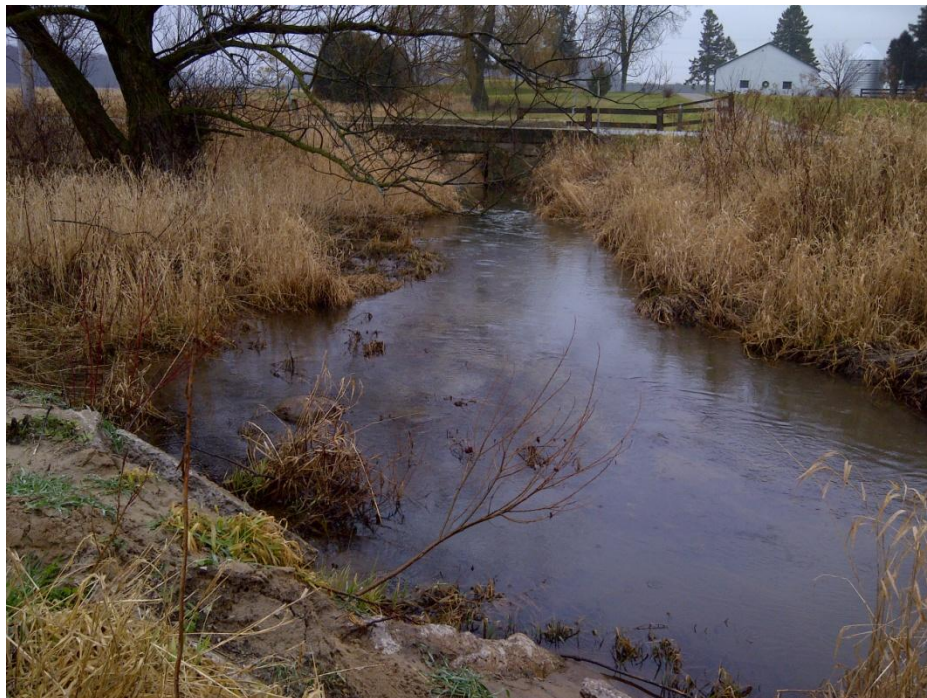
Photograph No. 6: View of Komoka/South Strathroy Creek as it exits south under Scotchmere Drive.
