L.P. #6:

8338 Scotchmere Drive
Strathroy-Caradoc

Scoped Heritage Impact Assessment

Prepared for Canadian Solar Developers
by Robinson Heritage Consulting

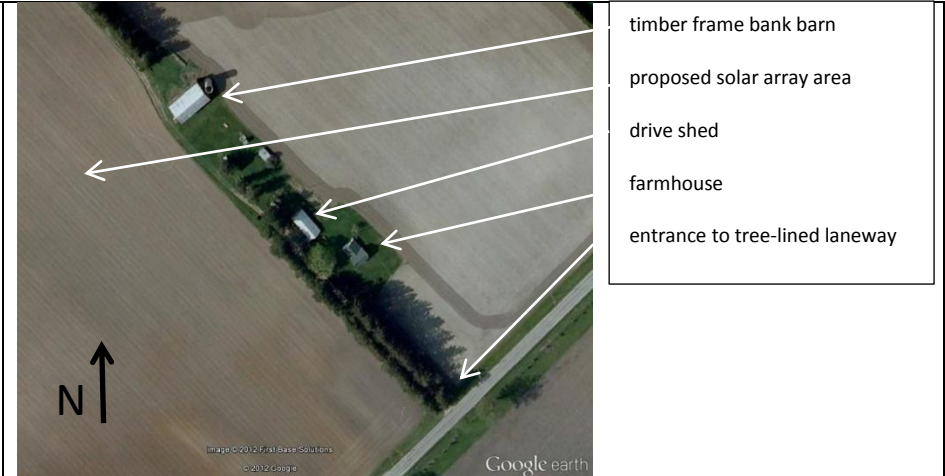
farmhouse is located 90 meters from the road (Figure 3). The surrounding context is large farms with many mature trees around the farm dwellings and large, open fields under cultivation (Figure 18).

Figure 3 - Orthographic photo of subject property. (Image: Google Earth, 2012)

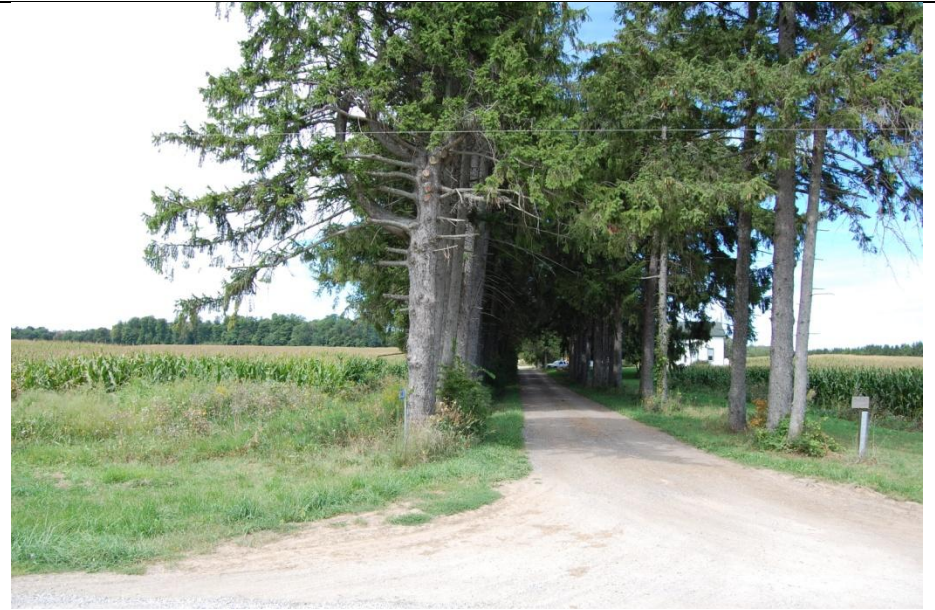
Figure 5 - View southeast, from gate. (Photo: RHC, Aug 2012)

The gravel laneway proceeds straight northwest past the farmhouse and drive shed to the bank barn at the rear. The tall, mature conifer (spruce) trees lining the laneway create a tunnel effect that largely screens views of the rear and the fields on both sides (Figures 5 and 6).

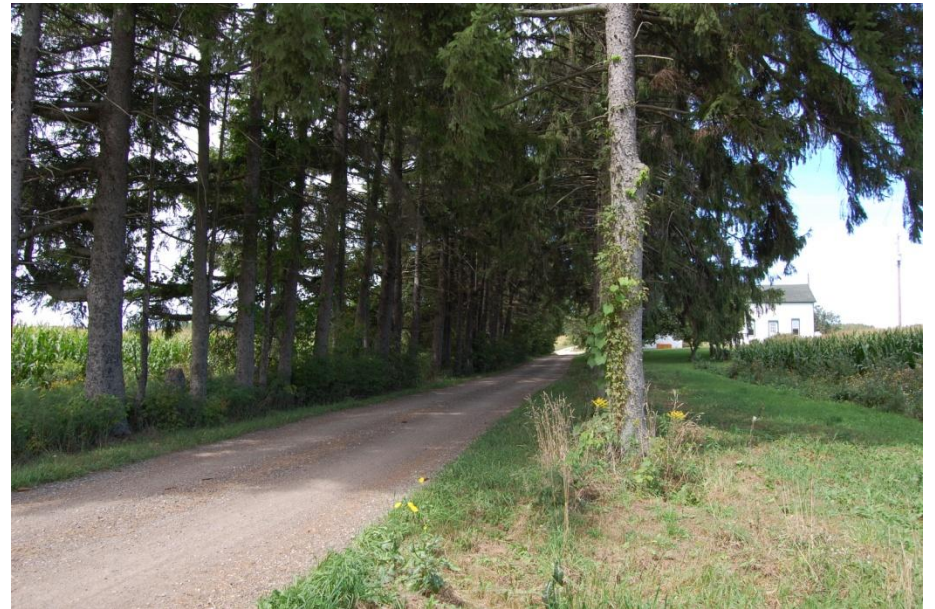
Figure 6 – View southeast, past house to barn. (Photo: RHC, Aug 2012)

(Figure 6). At this vantage point, all the viewer can see is the farmhouse on their right. Any view of barn and the working farm area is screened by the large mature trees.

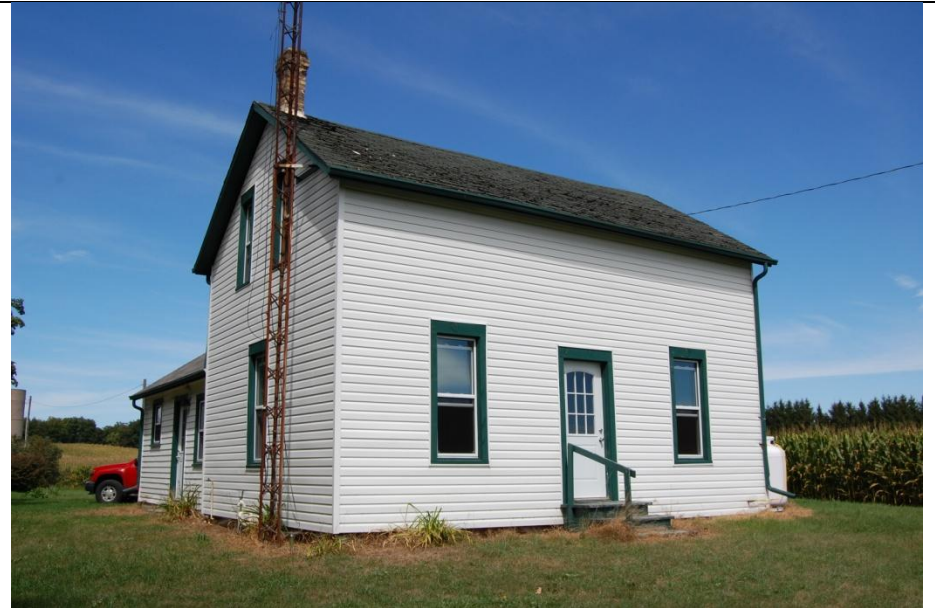
Figure 7 – Farmhouse, viewed from lane. (Photo: RHC, Aug 2012)

As one approaches along the laneway, the farmhouse comes into view on the right. This 1 $\frac{3}{4}$ - storey, Georgian farmhouse appears to be constructed in wood frame with an undetermined exterior cladding under the current modern metal horizontal cove siding.

The massing and style of this simple dwelling was a popular design in Ontario's rural domestic architecture from the early 19th to the early 20th century. The distinguishing features are the T-shape plan footprint with the main block of the house having a side gable main roof and a 3-bay front facade.

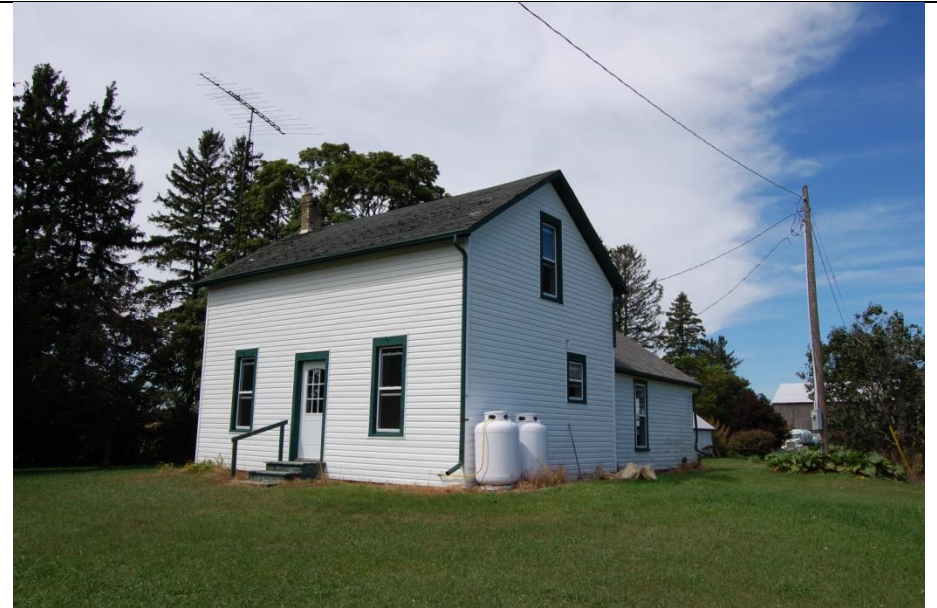
Figure 9 – View of farmhouse from east. (Photo: RHC, Aug 2012)

The extant chimney shaft rising from the west end of the roof ridge was constructed in corbeled white (yellow) clay brick which was a common building material in mid-19th century. The foundation wall of the main block of the house was constructed using the same clay brick. The type of clay used to make this type of brick is found in the London and Middlesex area and, therefore has become a typical feature of so many Victorian era homes and buildings.

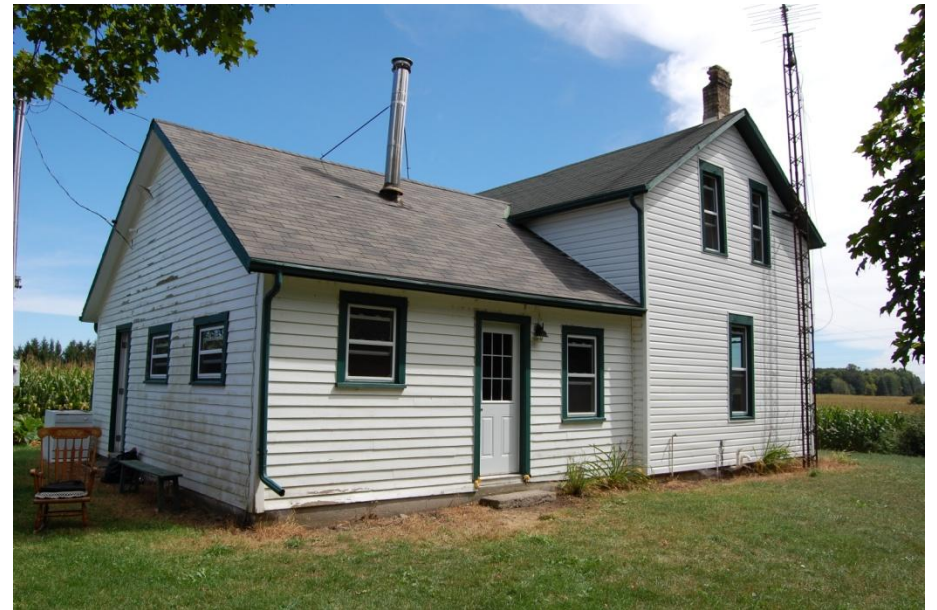
Figure 10 – Expanded tail at rear seen from laneway. (Photo: RHC, Aug 2012)

The perpendicular tail at the rear (Figure 10) sits on a poured concrete foundation and appears to have been expanded to enclose what would likely have been a side porch facing the laneway. The northeast side window opening on the tail appears to be original as it is a similar size to those on the front façade. As the tail is now clad in wood clapboard siding, this alteration is likely to have occurred in the mid-20th century.

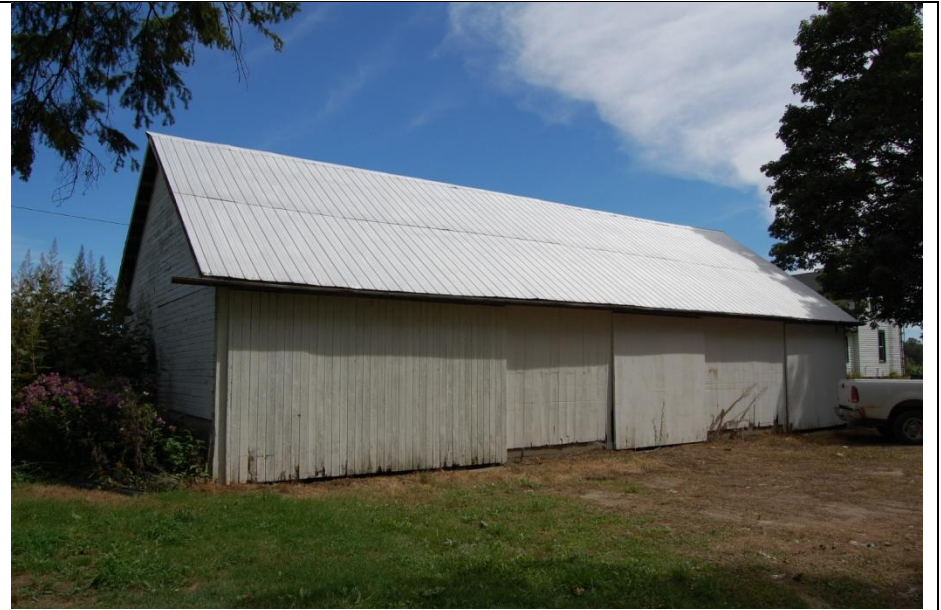
Figure 11 - Drive shed (Photo: RHC, Aug 2012)

Past the farmhouse on the northeast side of the laneway is a large, wood frame, gable roof drive shed. The drive shed is clad in horizontal wood siding (Figures 9 and 10).

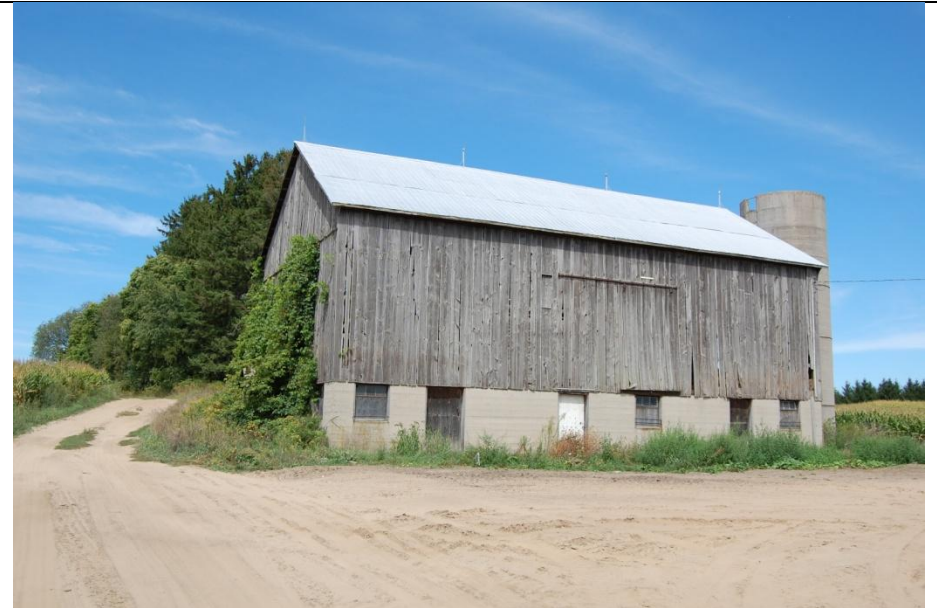
Figure 13 – Bank barn, viewed from southwest. (Photo: RHC, Aug 2012)

A large, English style, timber frame bank barn is located north of the driveshed and farmhouse. This type of barn with a gable roof is likely to have been raised in the later 19th century as the gambrel barn roof did not become popular until the mid-20th century. This may be an earlier barn that has been reconstructed on poured concrete foundation walls.

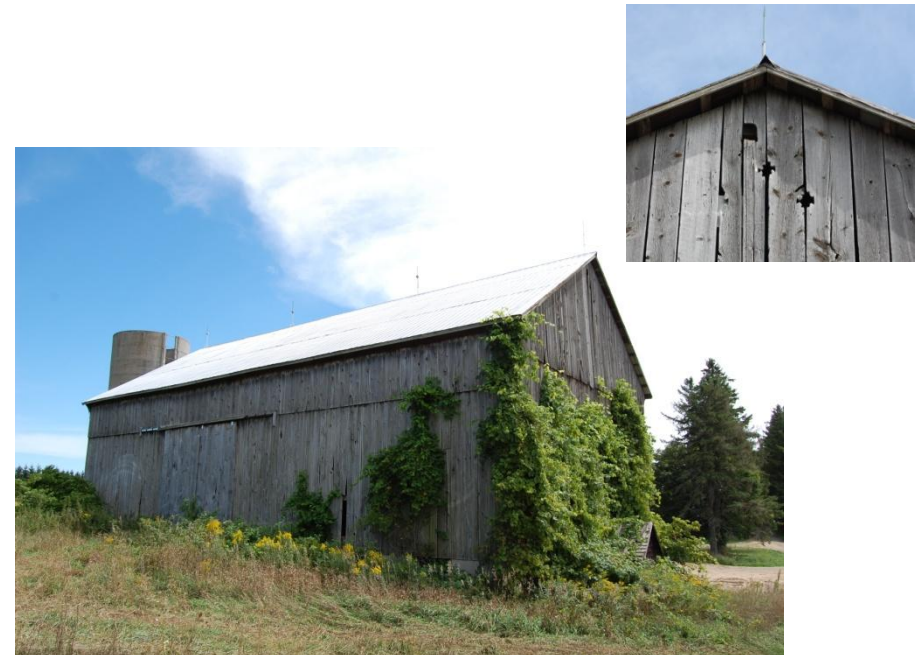
Figure 14 – Bank barn, viewed from south, (upper right) detail of shapes in barn boards. (Photo: RHC, Aug 2012)

Of note are the three cruciform shapes cut into the barn boards near the peak of the southwest gable wall.

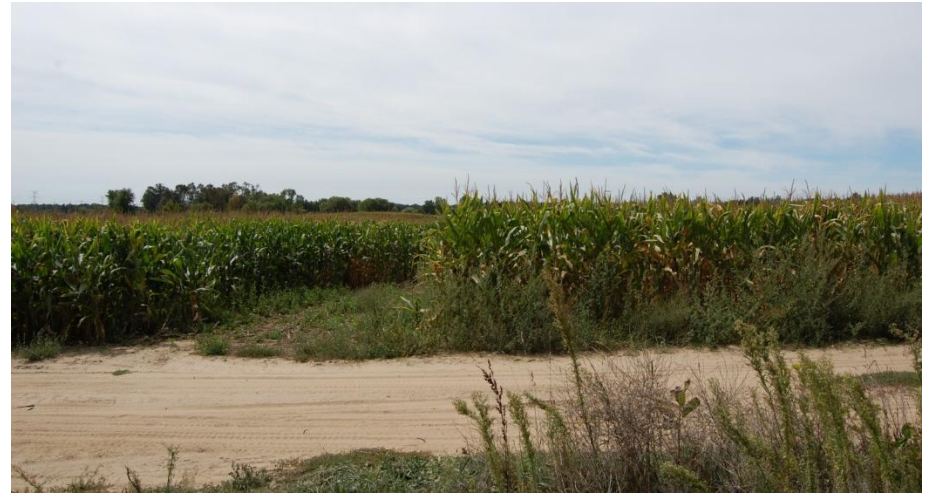
Figure 15 - View to west of proposed solar array area from bank barn. (Photo: RHC, Aug 2012)

The array would be located on what is now a cornfield to the southwest of the timbre frame bank barn (Figures 17 and 18). The view from the southwest corner of the barn toward the solar array is approximated in Figure 14.

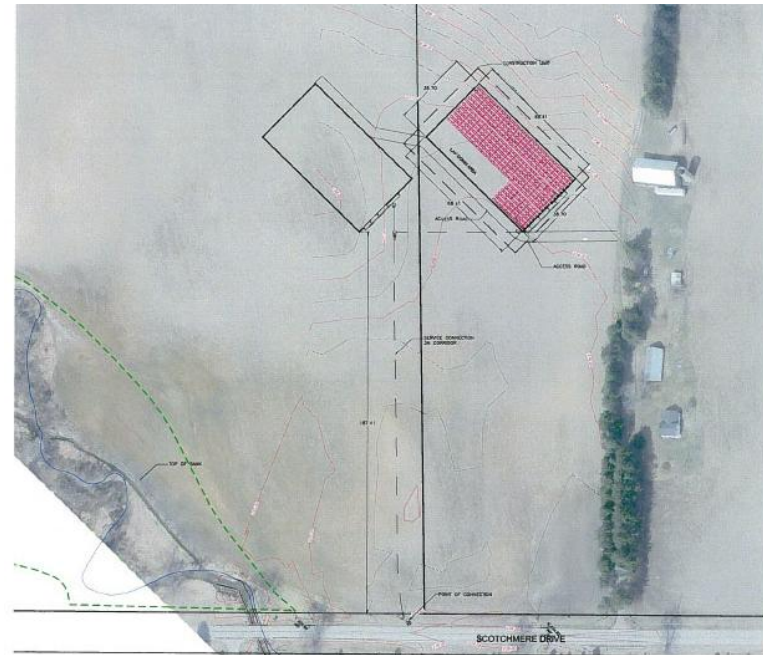
Figure 16 - Site Plan indicating proposed placement of solar array installation. (Image provided by Exp Inc. for Future Solar Developments Inc., 2012)

The arrays are to be installed on agricultural fields where the client has established long term leases. The client proposes to install a solar panel array with a footprint of 37m x 67m (~0.6 acres) (Figure 15) and panels with a height of approximately 1.5 to 1.8 meters from the ground (Figure 16).

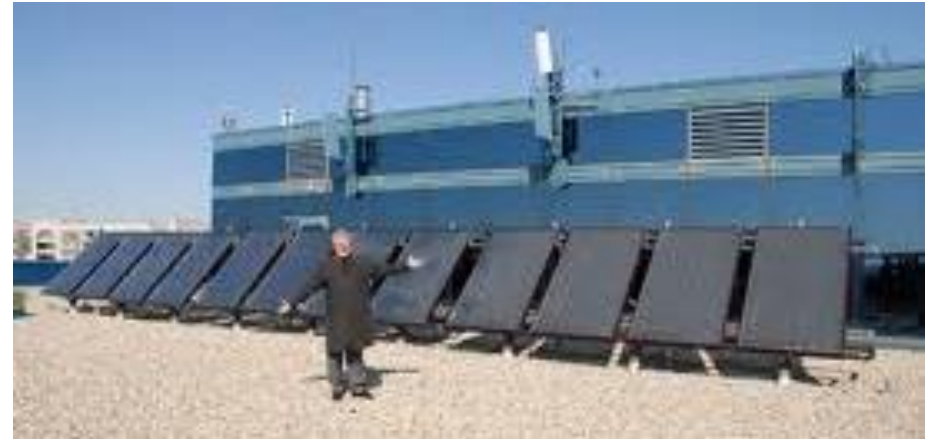
Figure 17 - Relative size of proposed solar panels. (Image provided by Exp Inc.)

Figure 17 shows the relative size of the proposed solar panels. Figure 18 shows the current view of the farm from Scotchmere Drive. The solar array would not project visually above the tree line on the horizon.
